**Report to the Maryland Public Service Commission
on the Progress of the Maryland Electric Reliability Tree
Trimming Council (MERTT) in Addressing Commission
Order # 79159 Regarding Recommendation for Specific
Actions that Utilities Can Take to Best Manage Privately
Owned Trees Adjacent to and within Utility Rights-of-Way.**

August 2010

**MARYLAND POWER PLANT
RESEARCH PROGRAM**

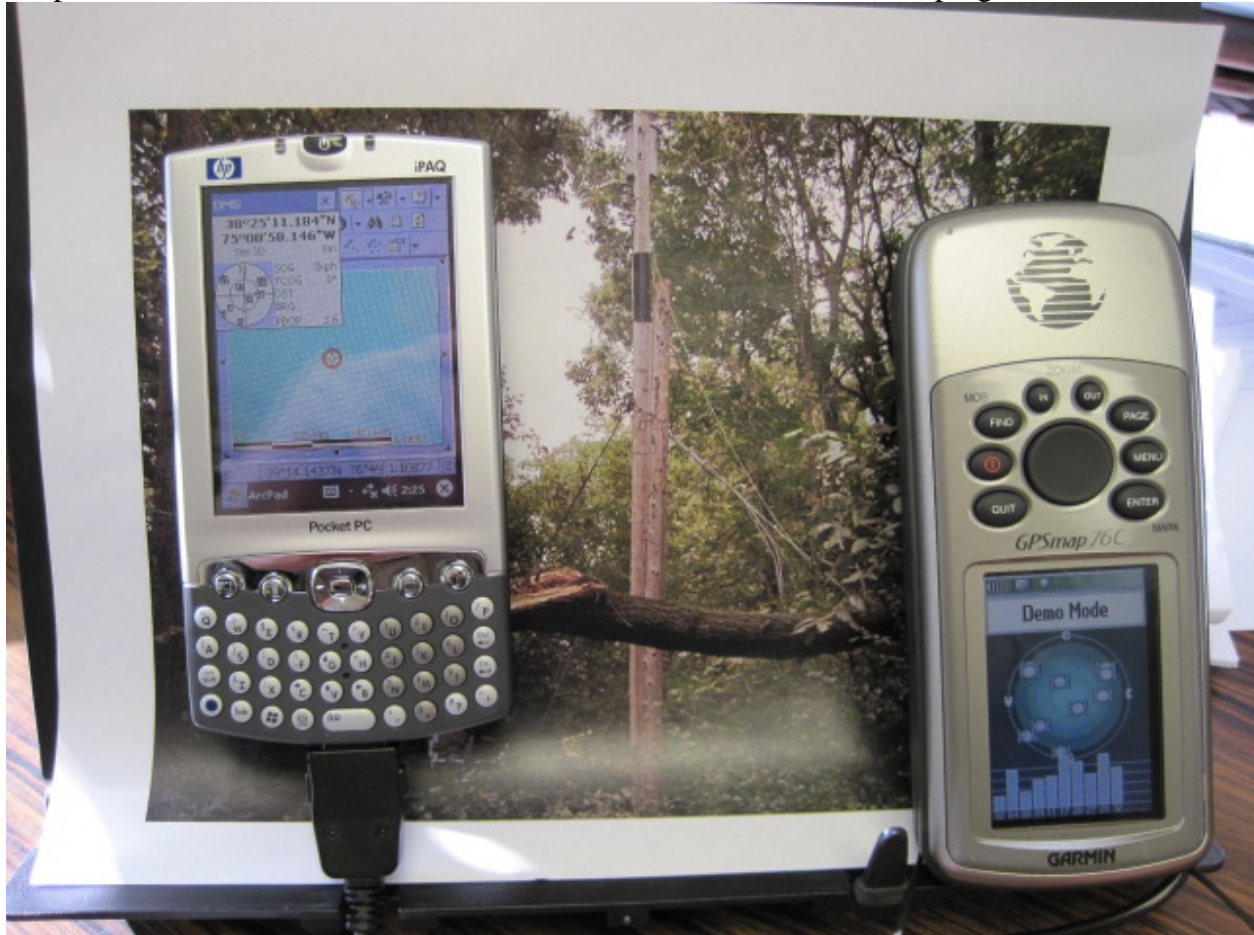
Figure 1. Pocket PC (left) showing ArcPad display screen with satellite window; positional data is received from GPS (right).

To facilitate and standardize the information collected on tree-caused power outages, each utility forester has been supplied with a tree-data collection system composed of a Personal Digital Assistant (hp iPAQ PocketPC) with ArcPad 6.0 software linked to a Global Positioning System (Garmin GPS Map 76C) (Figure 1). Maryland DNR Forestry developed a data collection template with the ArcPad software to be used for the MERTT Tree-data program.

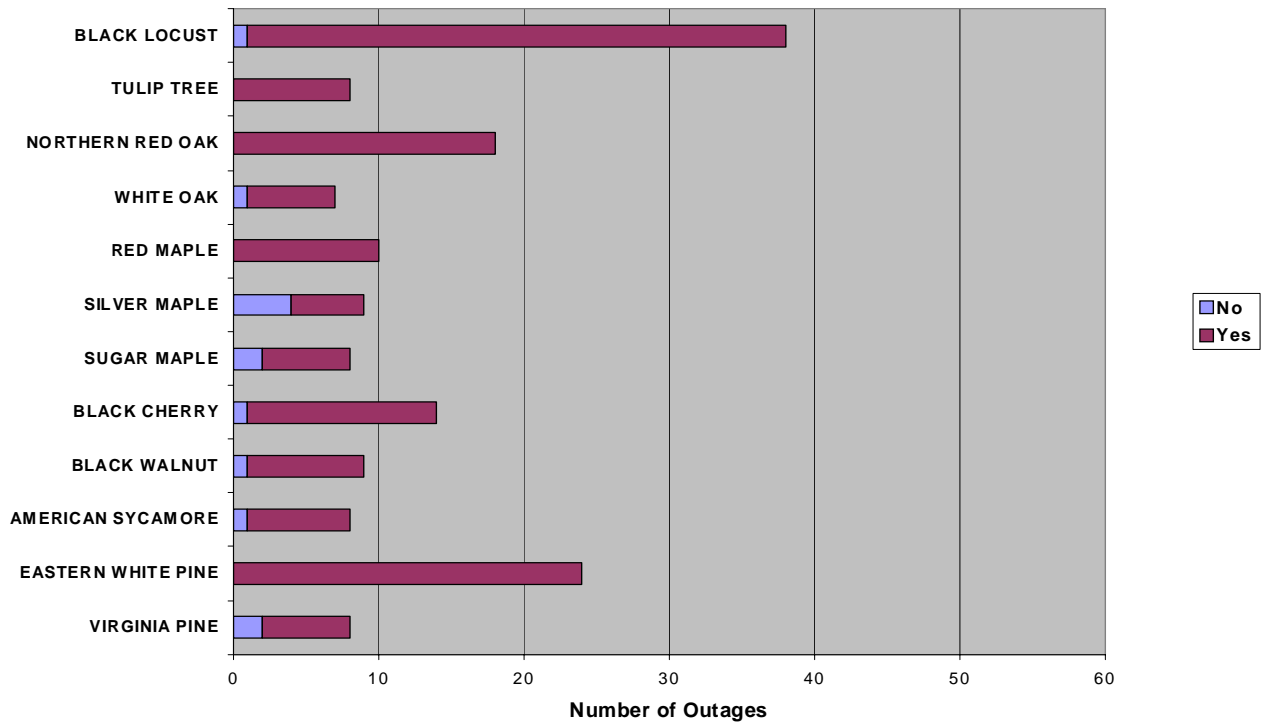
Western Region - Tree from Off ROW

Figure 10. Outage Causing Trees - Off vs On Right of Way, Western DNR Region

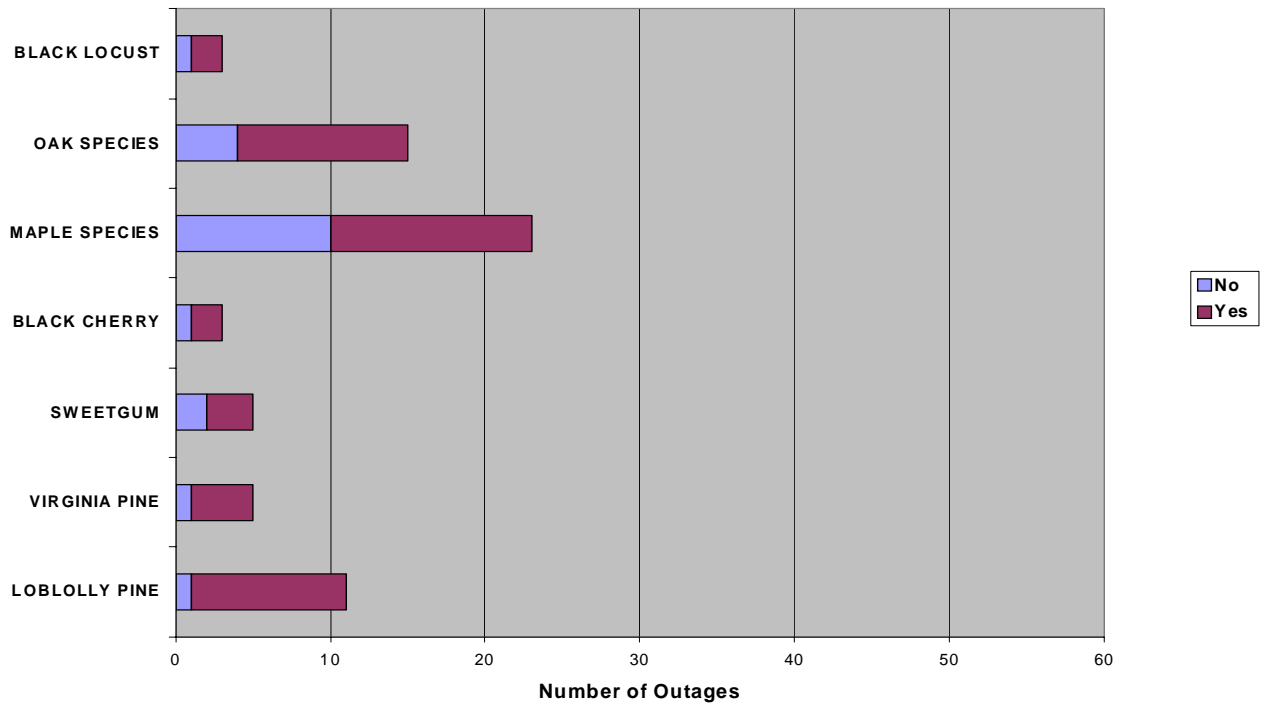
Eastern Region - Tree from Off ROW

Figure 12. Outage Causing Trees – Off vs On Right of Way, Eastern DNR Region

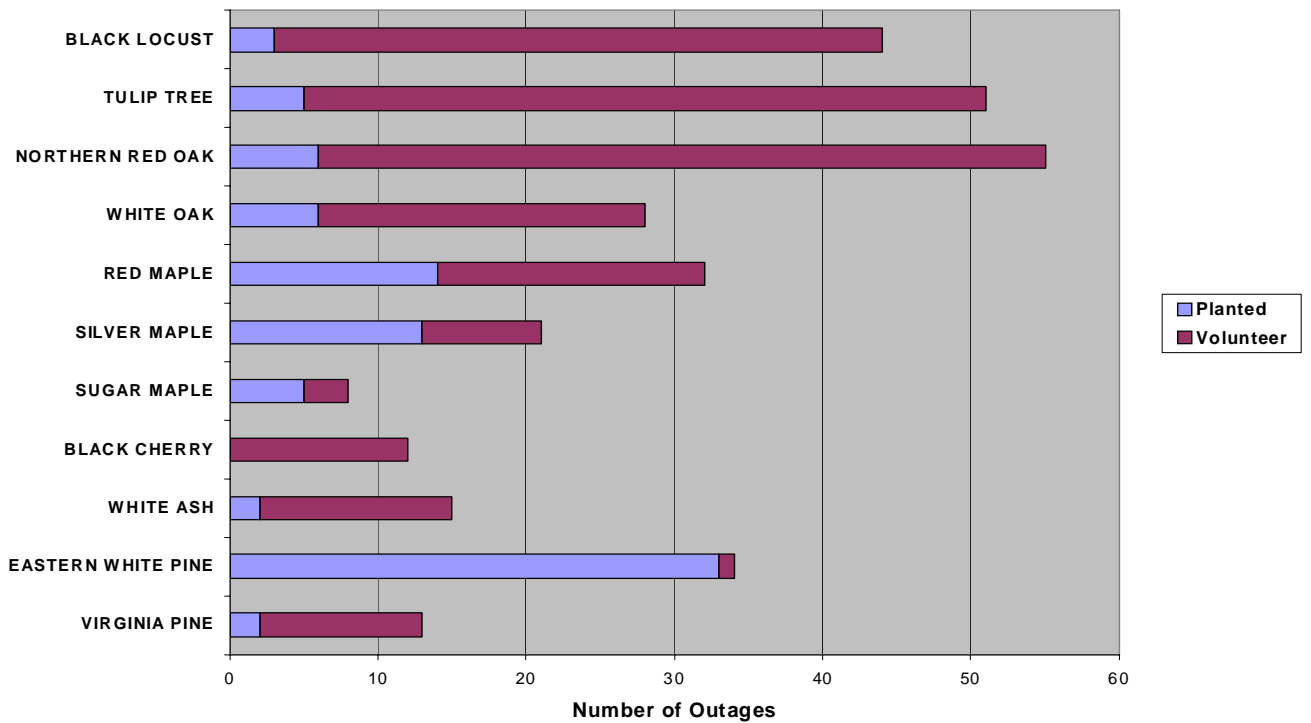
Central Region - Species Origin

Figure 15. Outage Causing Trees - Planted vs Volunteer, Central DNR Region

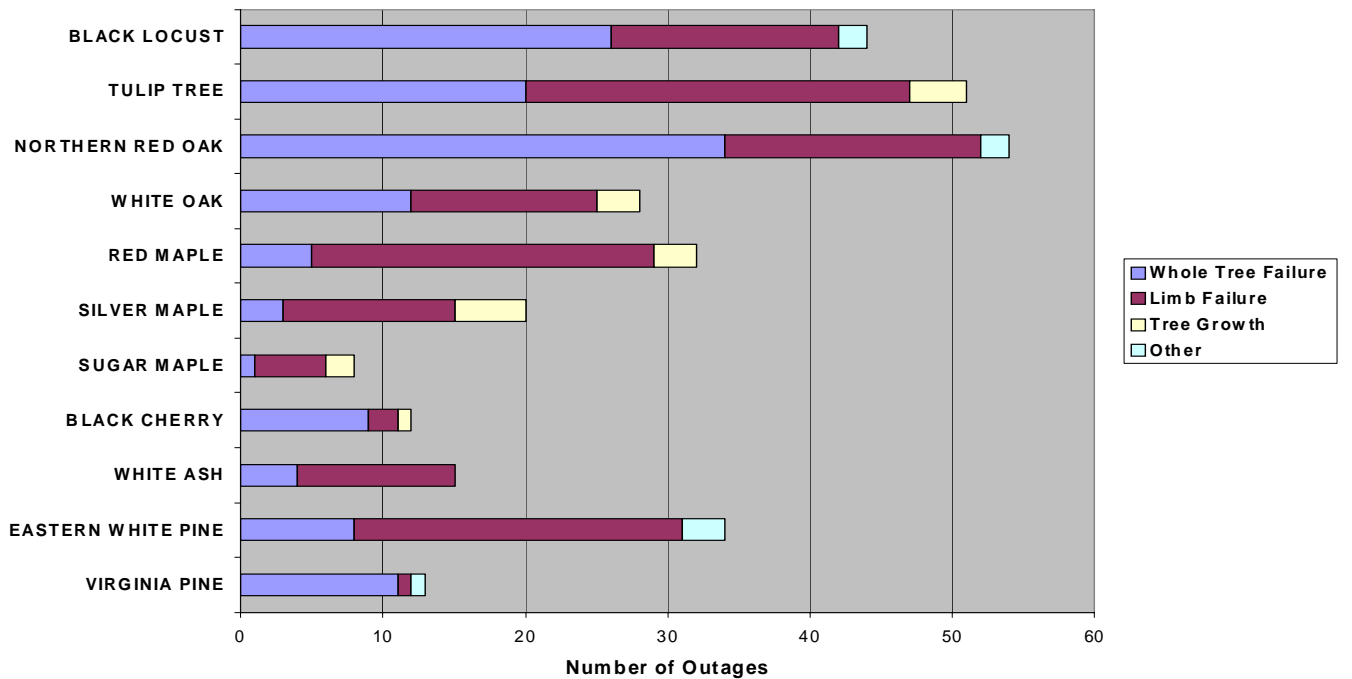
Central Region - Species Field Cause

Figure 19. Type of tree failure by species, Central DNR Region
